ST JULIENS CREEK OCEAN CONSTRUCTION EQUIPMENT INVENTORY 1/2

The purpose of this document is to present the anticipated needs of the OCEI Support Facility at St. Juliens Creek over the next five years. It is a planning document designed to provide sufficient background and data so that the reader can effectively utilize the proposed recommendations and conclusions. The scope of the document is intended to provide the information required to justify appropriation requests.

A Five Year Plan for the OCEI Support Facility at St. Juliens Creek, Portsmouth, Virginia, is presented. The plan is developed from internally generated planning documents, information collected in a detailed site assessment, and a Basic Facility Requirements (BFR) study. The analysis indicates that the existing facility has adequate storage, maintenance, and administrative spaces, but that significant changes and improvements are warranted to meet future support requirements of the OCEI and to increase the facility's efficiency and habitability. Repairs, modifications and additions are proposed to meet these needs. The recommended changes are costed and prioritized for FY84 through FY88. Expeditious decisions re

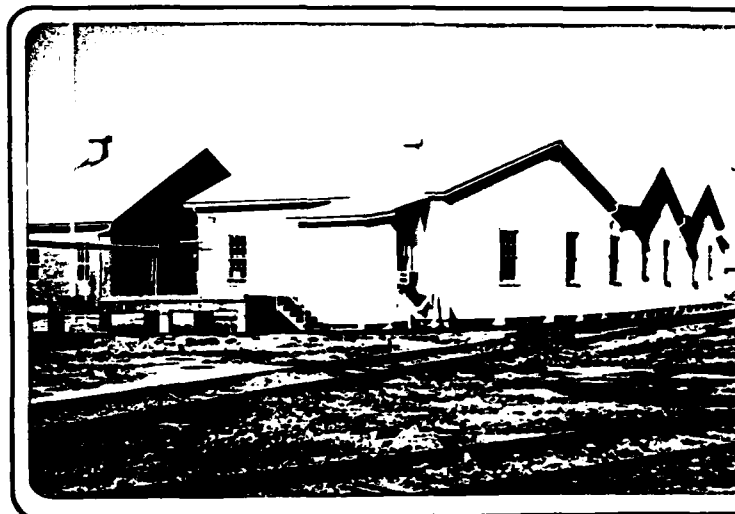
Outside, the associated grounds are lightly grassed and poorly drained. The building is flanked by Water Street on the northwest, Production Street

Figure 3-2: View of Building 43 showing loading platform on south end and gables on east side of building. (Spring 1983)

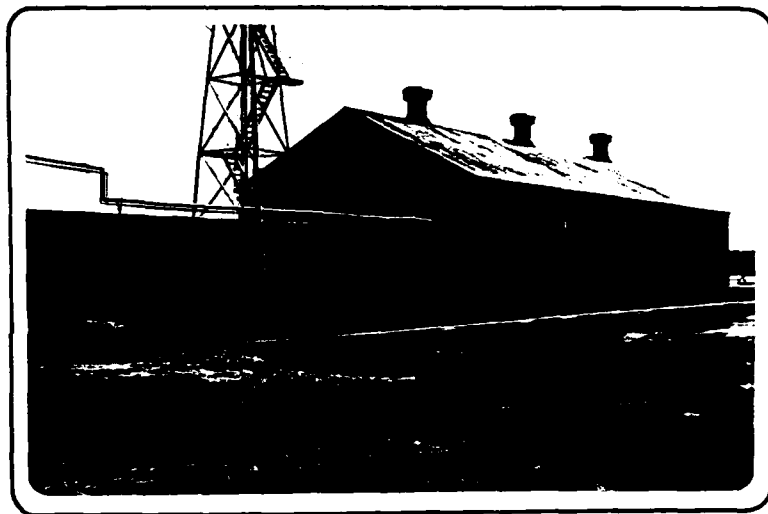
Outside, the wharf is paved with concrete on the north, east and south sides. Water lies directly off the building's west side. Three railroad tracks run along the wharf on the east side. A large steel tower is located four feet from the north loading ramp. The nearest utility pole is 50 feet to the northeast and the nearest fire main is 75 feet to the northeast. Adjacent to the building on the north side is a corrugated, metal storage shed measuring 54 feet long, 15 feet wide and 9 feet high used for storage of a forklift and petroleum products. (See Figure 3-5.) This 6000 pound capacity forklift cannot be used in the building due to the foundation's uncertain structural integrity.

Figure 3-5: View of Building 45 showing west side of building. (Spring 1983) Note storage shed and tower on left.

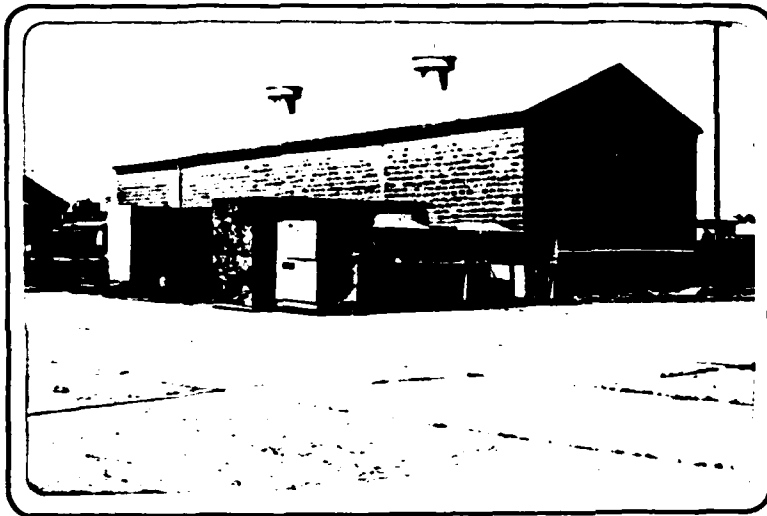
Figure 3-7: View of Building 83-Y showing east side and north end (Spring 1983).

Building 83-Y is adequate in size, for its present and future requirements. For an upgrade in utilities, it needs an improvement in utility. These items are discussed in

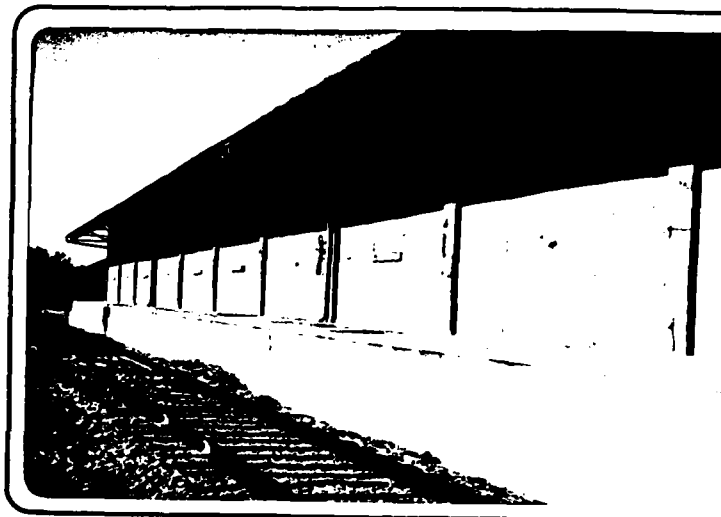
Building 169-Z is adequate in size but not in capability to accomplish its present and future requirements. Although the south wall is lined with tall, heavy-duty steel shelves which store materials efficiently, the building needs an upgrade in utilities and an improvement in equipment transfer capability. The building's present facility support equipment includes a pallet jack and a 6000 pound capacity A-frame. However, there is a need for a loading device which can efficiently transfer material to heights of 14 feet. These items are discussed in paragraph 3.2.4.2.

Figure 3-8: View of Building 169-Z showing south side (Spring 1983).

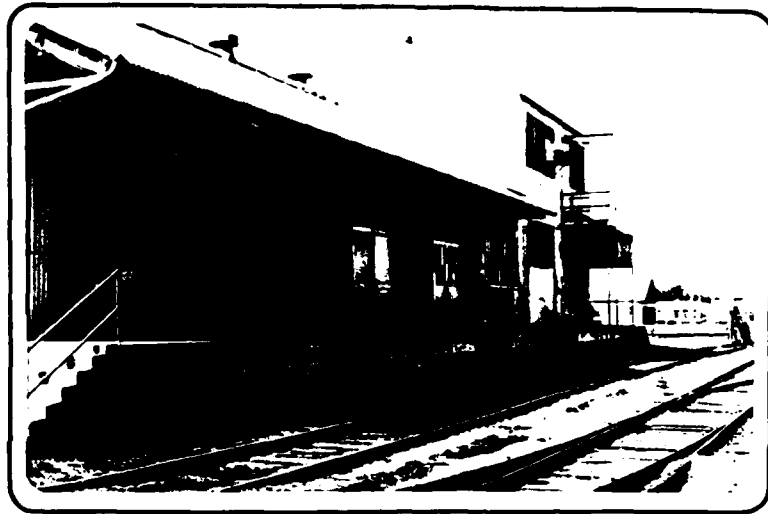
Outside, Building 185 is flanked by poorly drained, grassy areas on the northwest and northeast, by Water Street on the east and by a paved parking area on the southwest. Access to the parking area from Water Street is restricted by a steam line located 25 feet above the ground and laid along the building's east side. A large earthen bunker lies approximately 60 feet from the building's

Figure 3-12: View of Building 185 showing northeast side (Spring 1983).

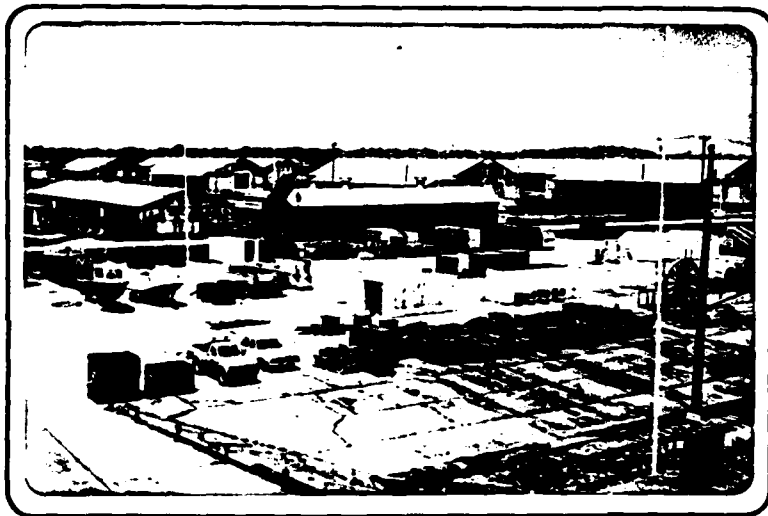
Figure 3-21: View of Hardstand as seen from south-east corner (Spring 1983). Note Building 83-Y in the background.

The majority of cable reels are covered by wooden boards which affords some protection. However, many reels are

There are several changes needed to improve the Hardstand Area. The first involves the protection of the equipment and material stored there. The material and equipment stored on the Hardstand Area are arranged in no apparent order and are exposed to the deleterious effects of rain, sunlight and salt spray. Only the items that are permanently assigned to the area are being staged for a current project, or are adequately protected from the elements should be stored on the Hardstand Area. The remainder
